Re: City of Meta – Stormwater Improvements
Preliminary Engineering Report

Introduction

Study Area and Purpose

Existing Conditions

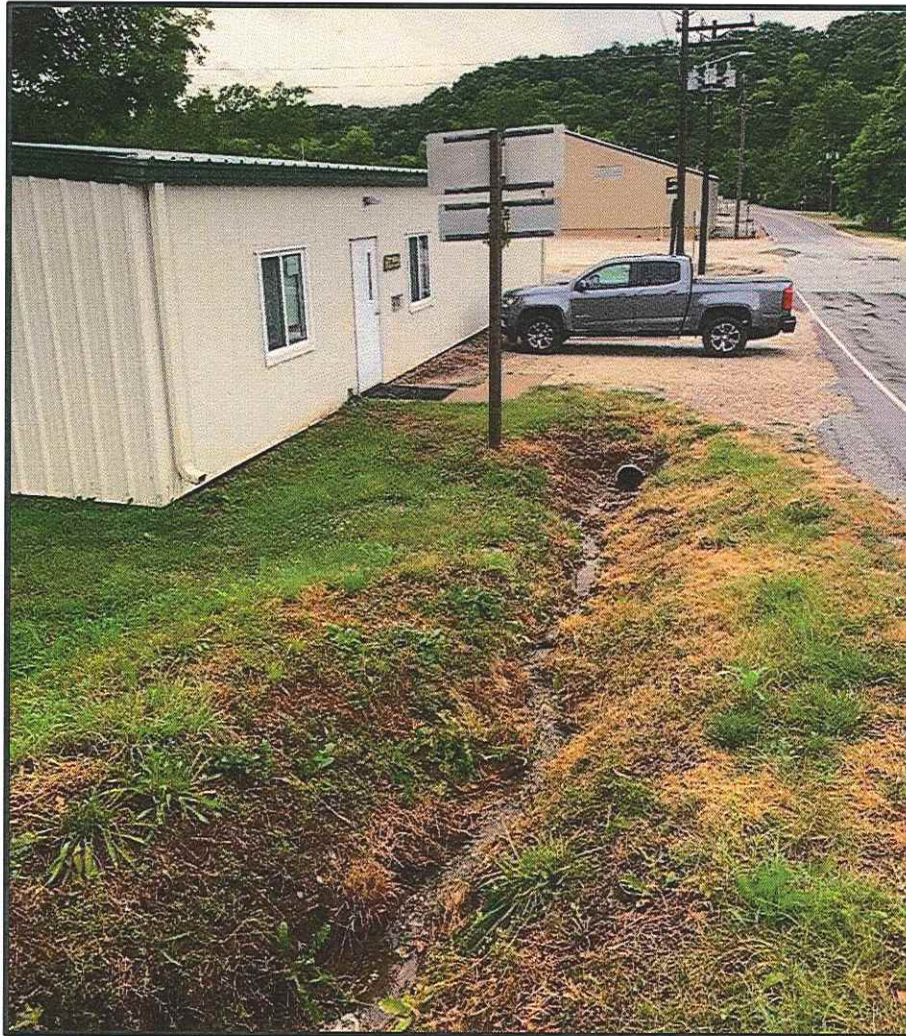
Meta City Hall is situated just southeast of the intersection of Third Street and MO-133. The roadside ditch on the northeast side of the intersection is collected by an 18" CMP and outlets on the southeast side of the intersection through a 12" CMP just north of City Hall. After a steep, short section of ditch, the drainage is directed to a 12" CMP culvert that passes under the City Hall parking area and continues south. During heavy rainfall events, discharging water from the intersection is not efficiently collected by the culvert under the City Hall parking area causing the water to backup into the low, flat area along the north side of City Hall. City officials have reported multiple instances of water entering the building due to the ponding water along the north and northeast side of the building.

Figure 3: 12" CMP under Meta City Hall parking area along MO-133

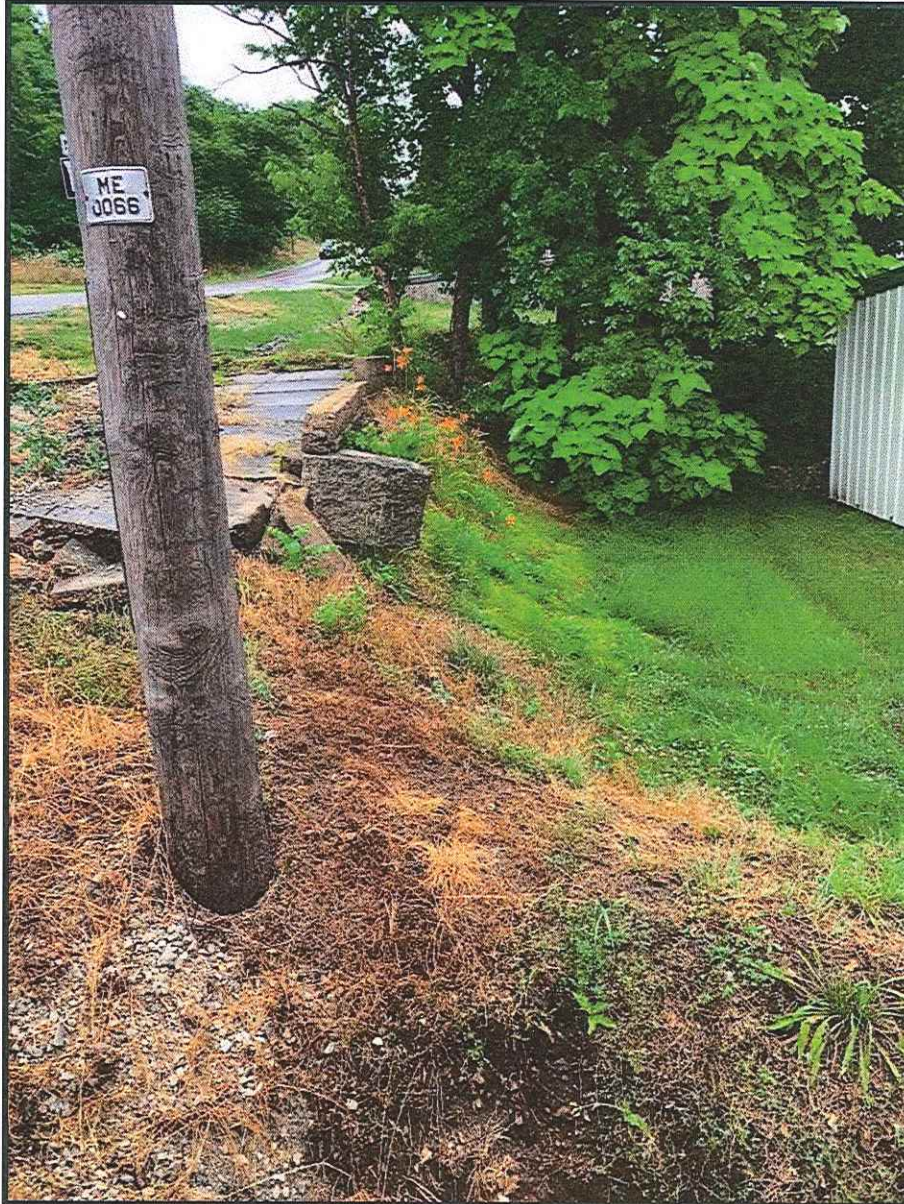
In addition to the flooding issues, the City expressed concerns about the conditions of the existing retaining wall along the southeast corner of Third Street and Locust Street. The existing wall that supports the roadway embankment is visibly deteriorating and could become a significant safety issue if ignored.

Figure 4: Deteriorated retaining wall along the southeast corner of Third St. and Locust St.

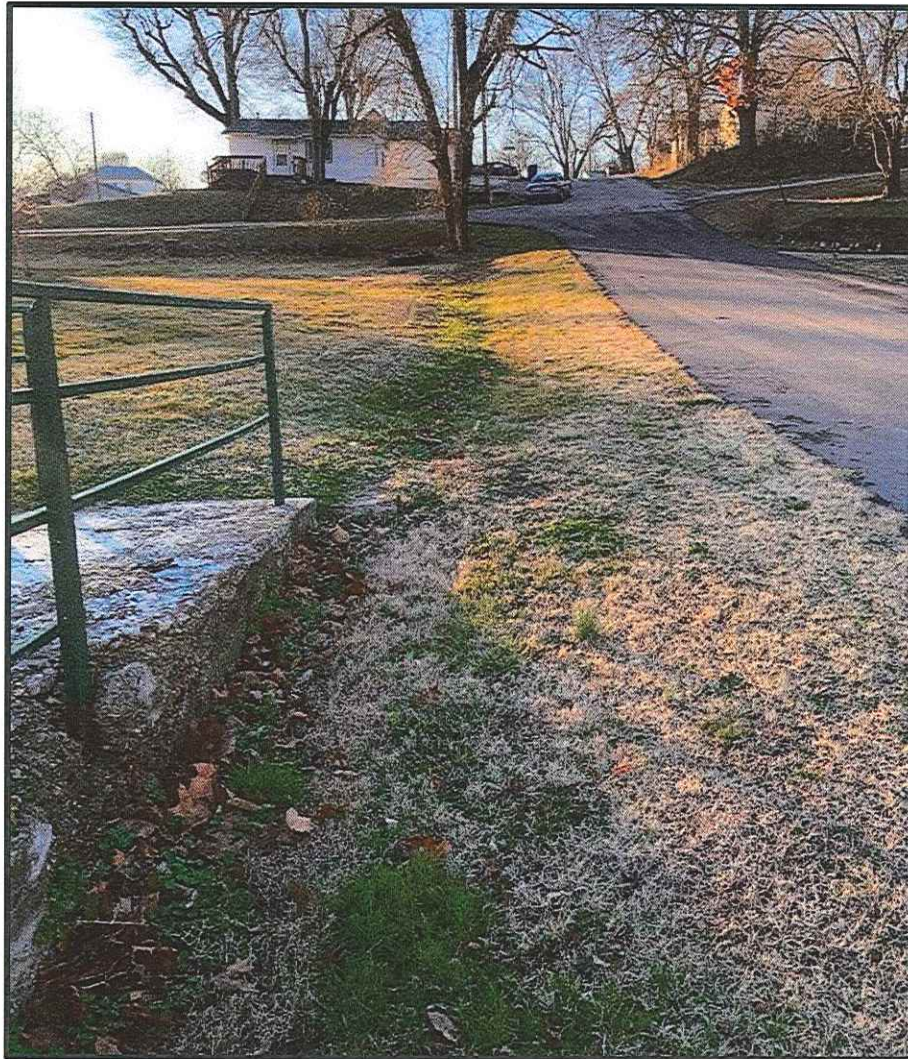
On the south half of the intersection of Sixth Street and Pine Street, there appears to be no existing culvert to pass water under Pine Street. Today, drainage from the southwest discharges at the base of a small block wall just west of the intersection. The runoff then freely drains over the roadway into the low area on the southeast side of the intersection. East of the intersection, a very shallow ditch along the south side of Sixth Street continues east to the nearby low water crossing. Without a culvert to control the runoff discharging across Pine Street, the roadway embankment is beginning to show signs of erosion. Furthermore, the lack of a defined ditch along Sixth Street causes more water to pond in the low area on the southeast side of the intersection. The residents of this property have voiced complaints about the lack of controlled drainage in this area.

Figure 7: Ditch along Sixth Street with minimal capacity

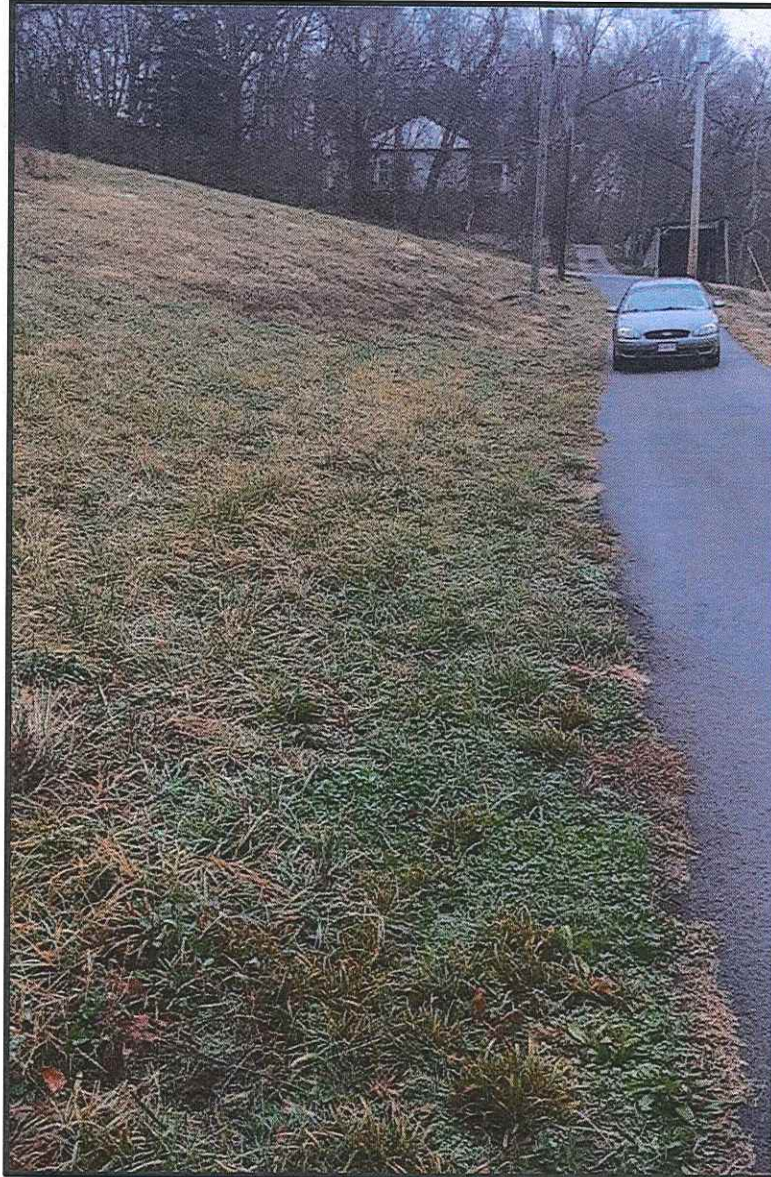
The empty lot north of Schriefer Street adjacent to Fourth Street and Locust Street was previously covered with mature trees and thick brush. In 2015, a developer cleared the property to make way for future development. The reduction in dense vegetation has increased the speed in which runoff sheet flows off the property to the south toward Schriefer Street. Schriefer Street does not have a defined ditch along the roadway; therefore, the runoff tends to flow over the road and continue south towards the commercial lots along Third Street. Mid America Bank and the local United States Postal Service office occupy the commercial space at the corner of Third Street and Bertha Street and have reported incidents of stormwater entering the building during heavy rainfall events.

Figure 9: Lack of defined ditch along Schriefer Street
